DEVELOPMENT OF DESIGN, TEST AND
ACCEPTANCE CRITERIA FOR ARMY HELICOPTER
TRANSPARENT ENCLOSURES

PPG Industries, Incorporated

September 1973

USAAMRDL TECHNICAL REPORT 73-65

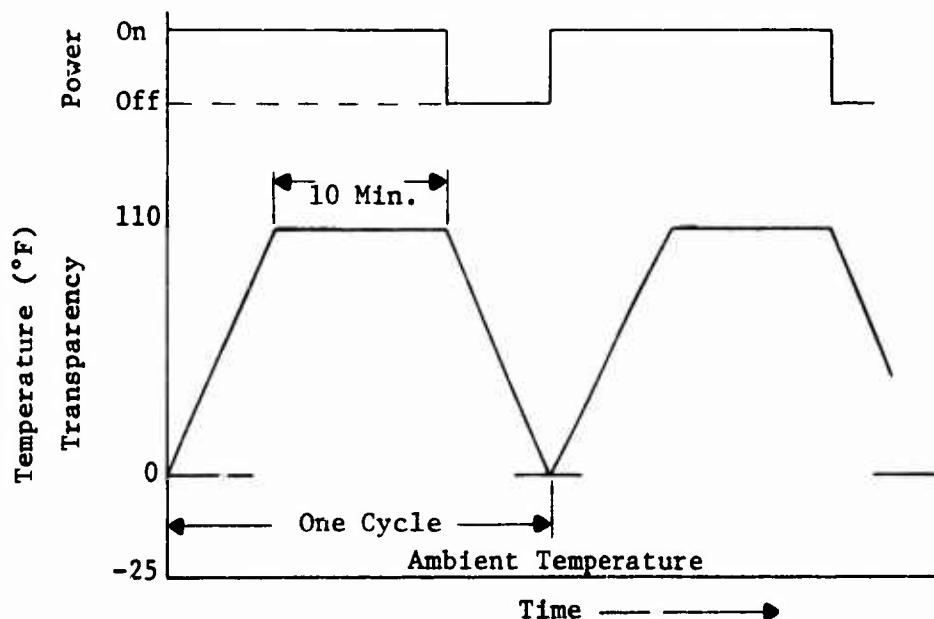
- 4.2.2 The transparency shall be operated with design operating voltage while exposed to the following environmental conditions. The transparency shall be placed in an environmental chamber maintained at -25°F . Operating voltage shall be applied through a suitable electrical controller with the windshield temperature sensing element connected to the controller. The windshield shall be allowed to cycle at design operating temperature for a period of 10 minutes. Power shall then be turned off and the windshield allowed to cool down. When the transparency temperature reaches 0°F , power shall again be applied. One cycle shall be as defined per Figure 1, and 1000 complete cycles shall be completed.

Figure 1. Cyclic Test.

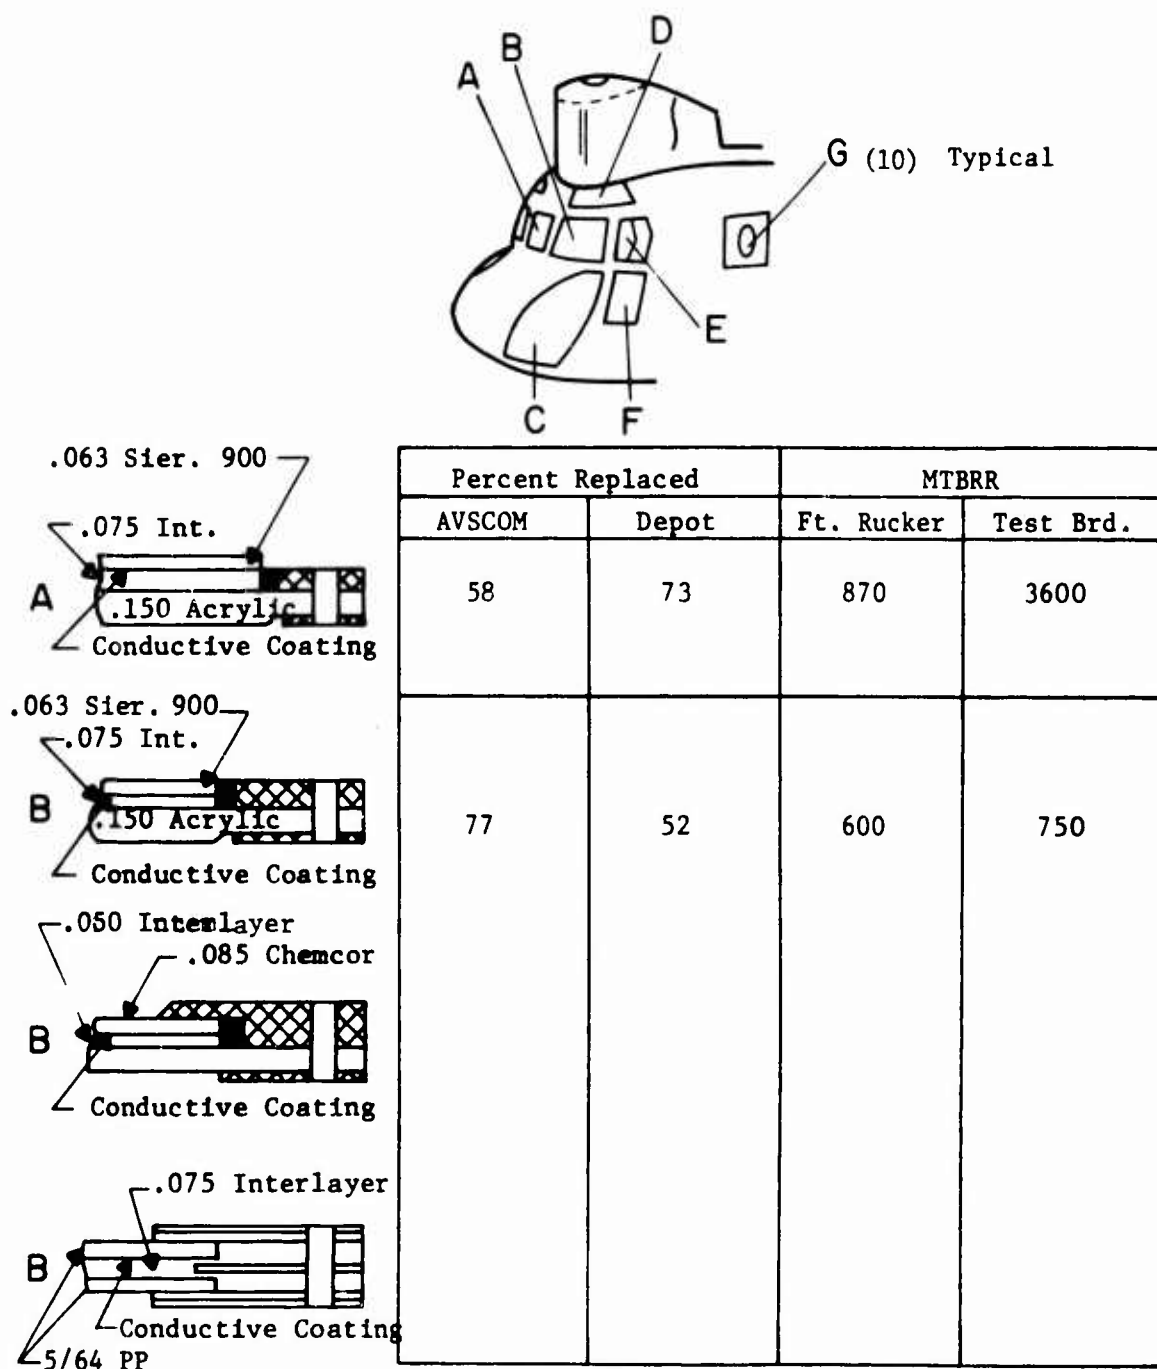
Figure 4 presents all usage rates obtained for all CH-47 transparencies. The ratings appear to indicate that the special features as used in the windshields cause the main problem. The combination of wipers and heating causes a rather low MTBRR of 600 to 870.

Figure 4. Service Performance of CH-47 Transparencies.

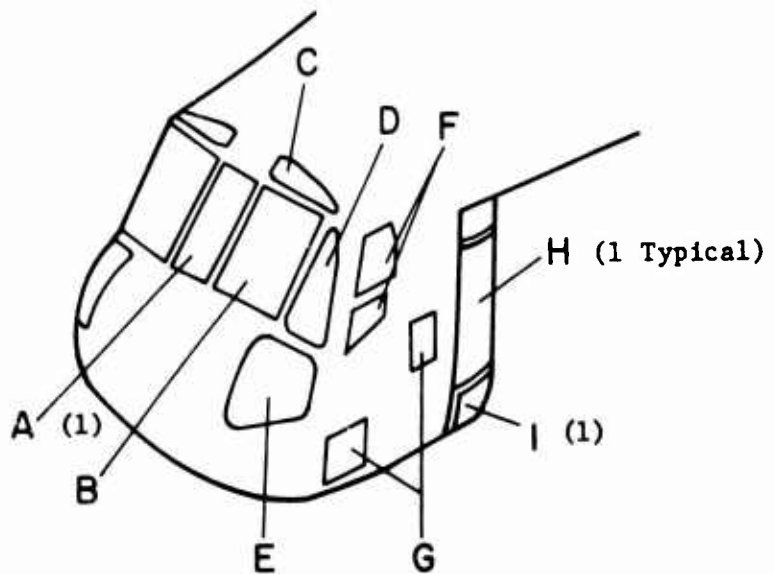
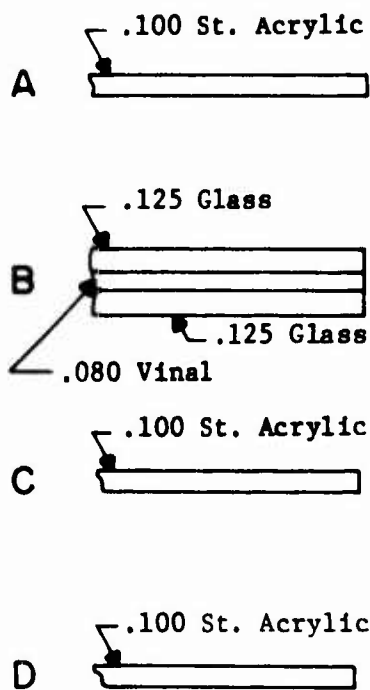
Results for the CH-54 windshield are rather sparse. The number of failures are very low compared to the estimated number of flight hours. In general, no comparative statements can be made for the glass-laminated main windshields and the stretched acrylic center panel. As shown by Table 43, all modes experienced are mechanical for these parts and the other transparencies, but scratching of the glass does not appear. However, it must be remembered that all three windshield parts are flat and unheated. Figure 5 tends to indicate satisfactory performance for all transparencies in the CH-54 helicopter, but actual usage has been minimal.

Figure 5. Service Performance of CH-54 Transparencies.

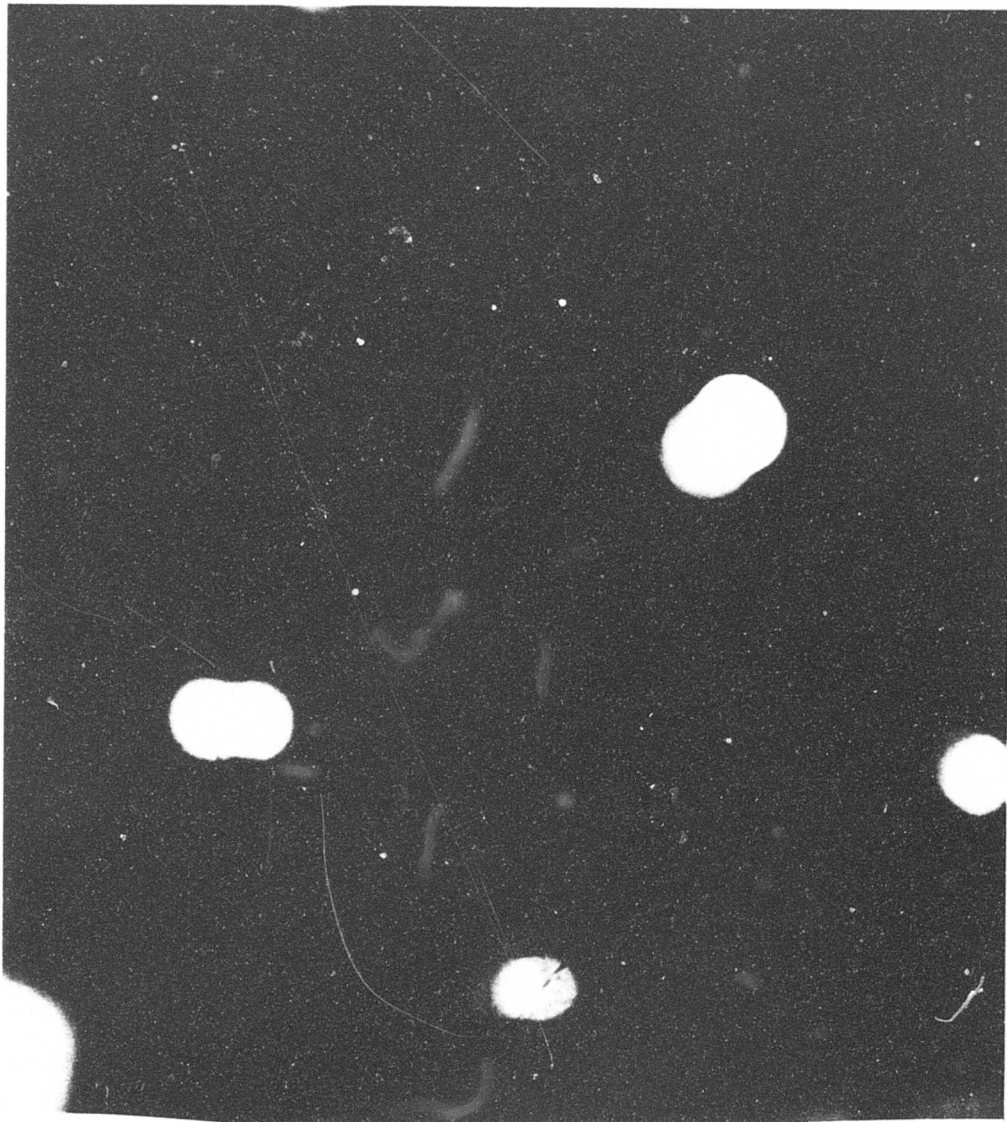
Figure 11. Double images (multiple reflections
Off Two Surfaces), OH-58.

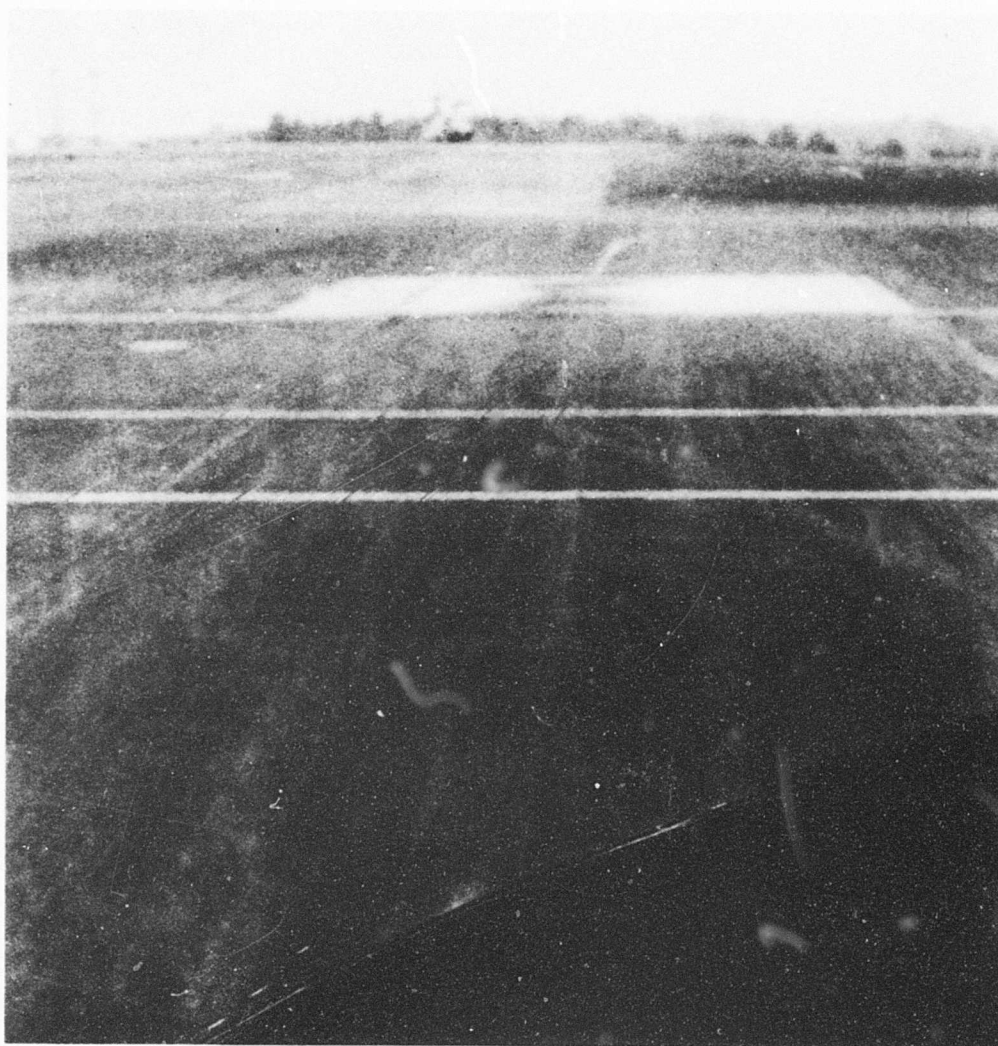
**Figure 12. Distortion Due To Repaired Scratches
on Plastic Windshield.**

Scratches on the surface represent the most common and widespread defect found. By far the most common cause was from windshield-wipers used on plastic-faced parts. Figure 14 shows wiper scratches on the UH-1. Similar damage was much less common on glass surfaces and were generally

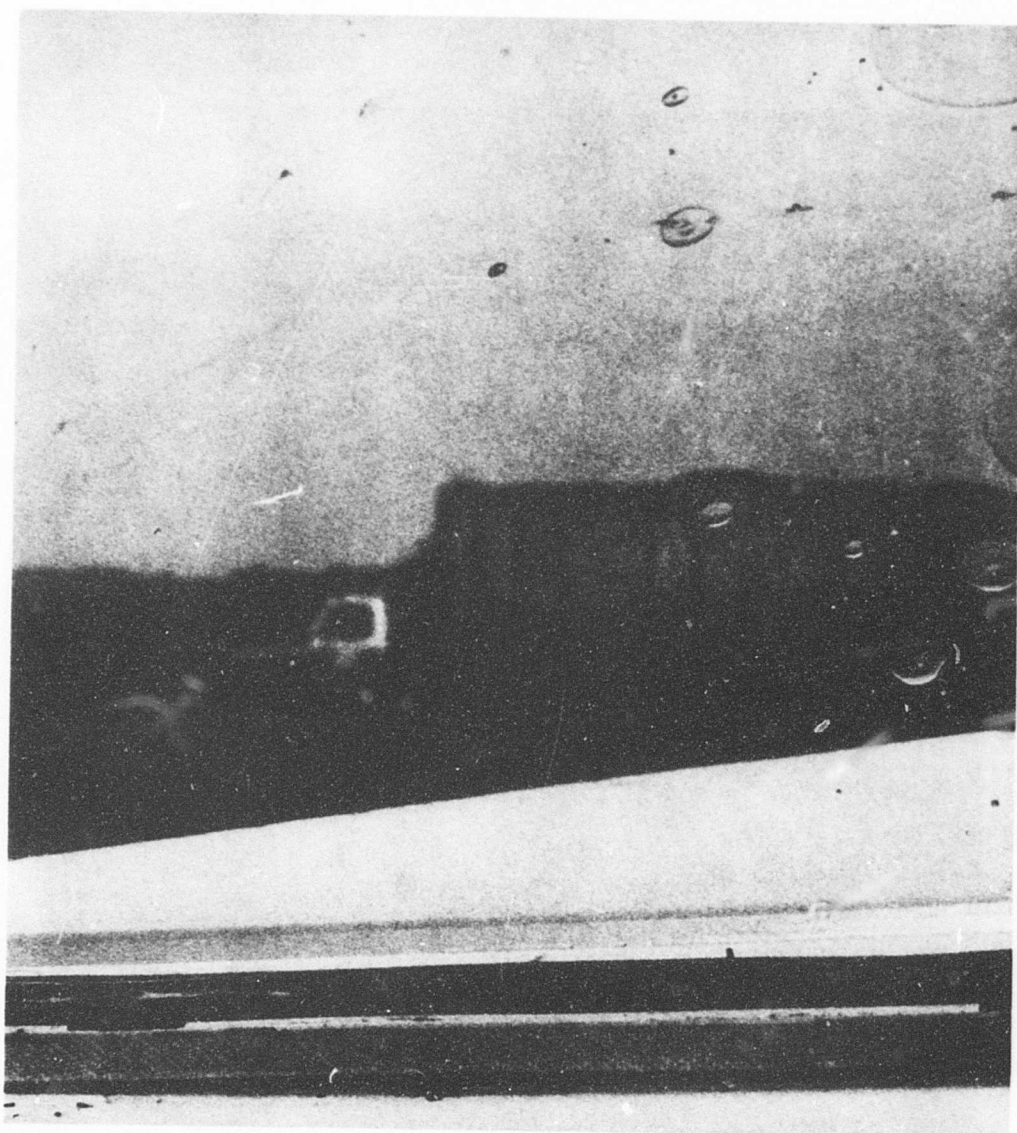
Figure 13. Distortion Caused by Delamination
of Plastic Windshield, CH-46.

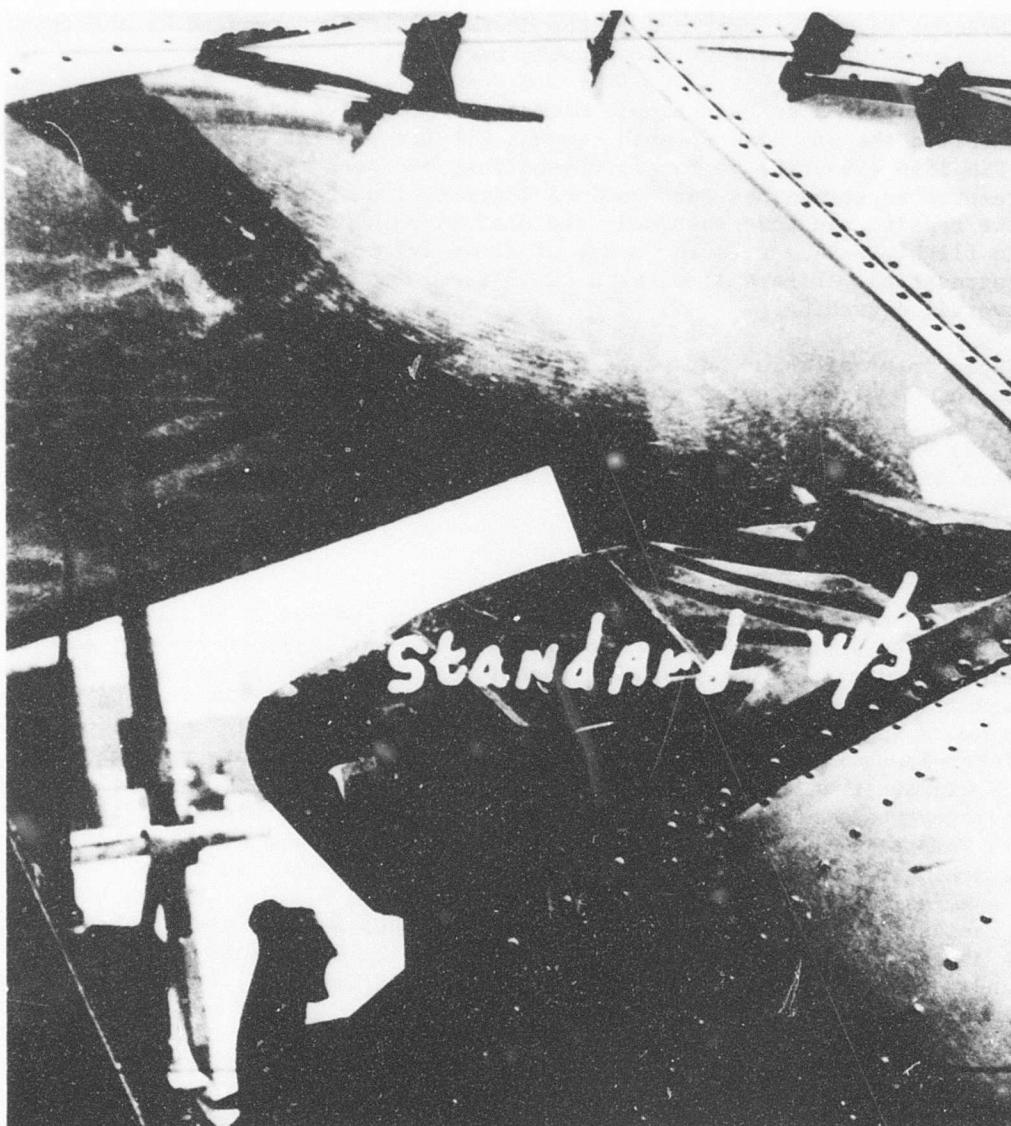
Figure 14. Wiper Scratches on Plastic Windshield, UH-1.

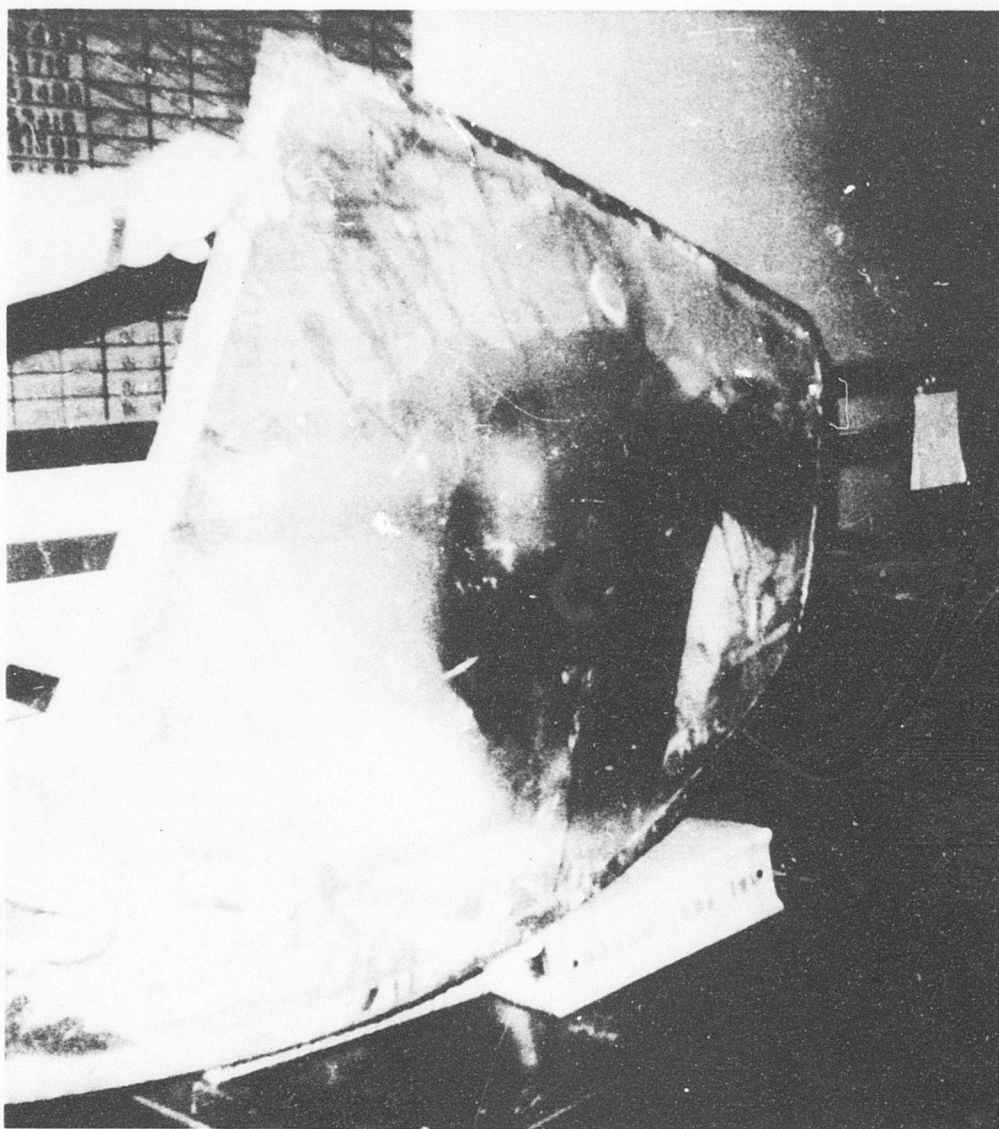
Figure 15. CH-53 Side Window Showing Scratches and Overall Degrading.

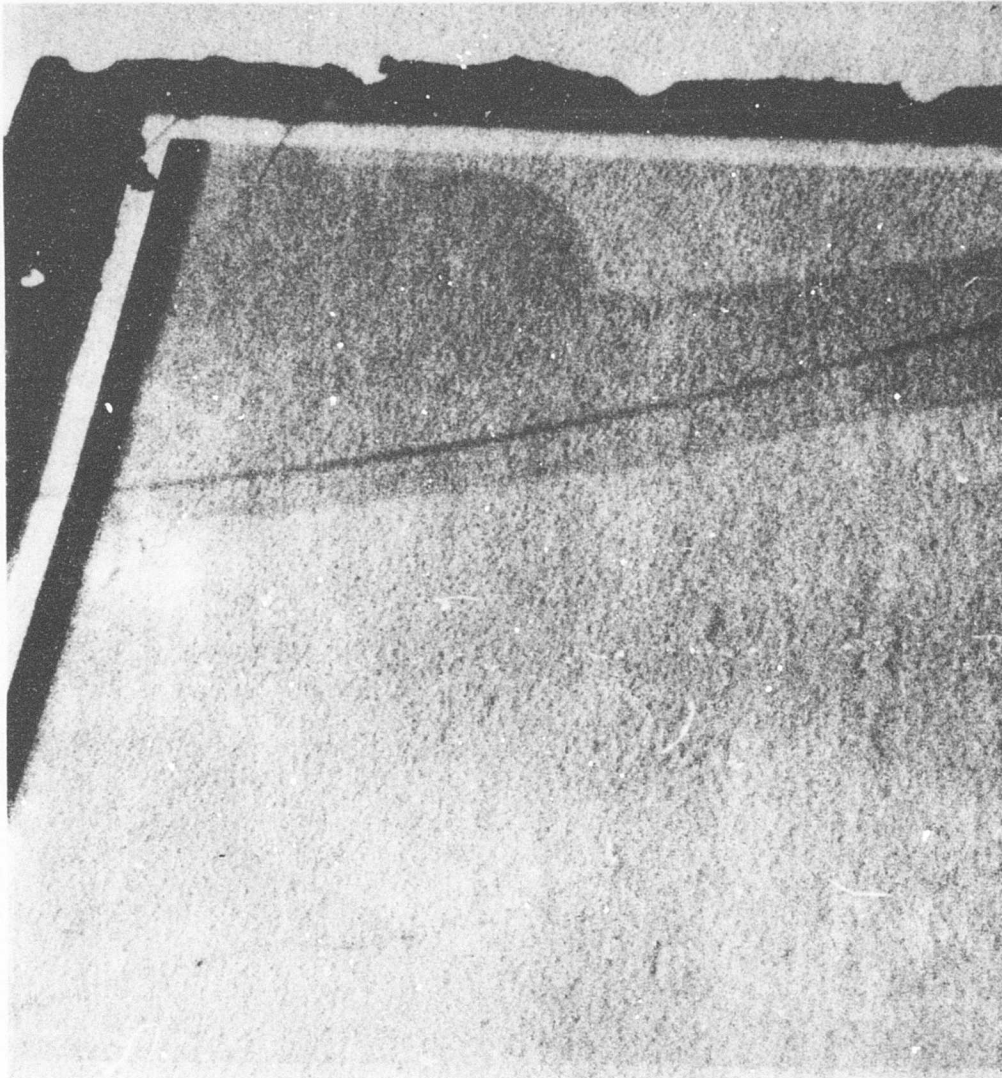
Figure 16. Crack in Plastic Windshield, CH-47.

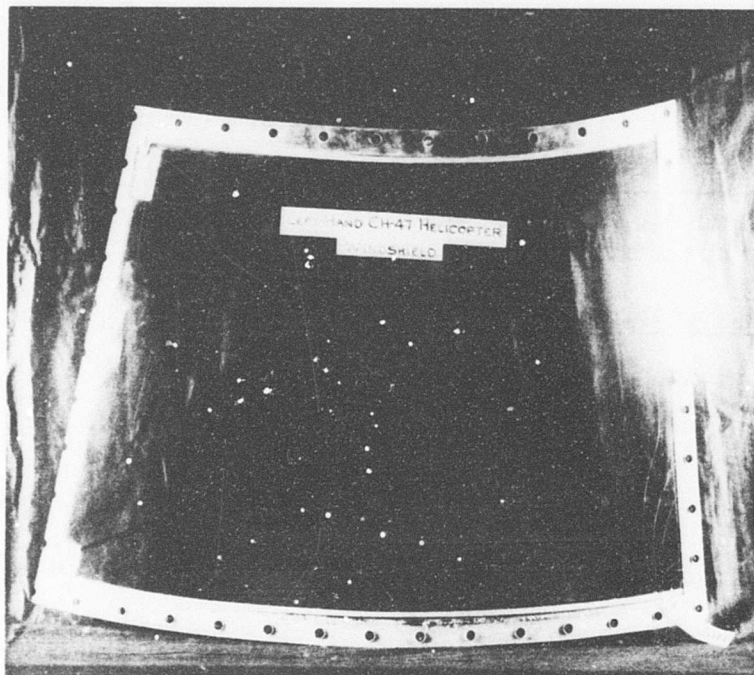
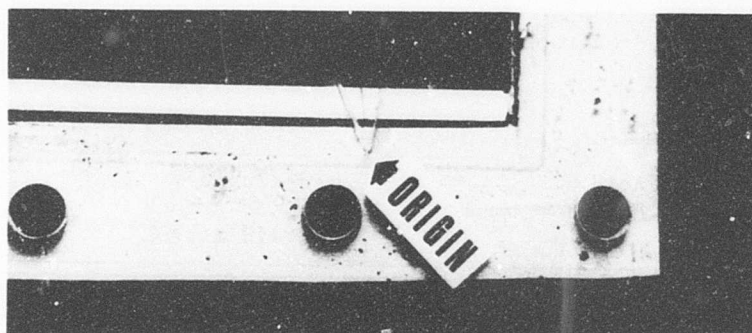
Overall Outside View Showing Break Pattern

Close-up of Fracture Origin Located at Edge Seam on Outside Surface

Figure 17. Breakage of Glass Windshield, CH-47.

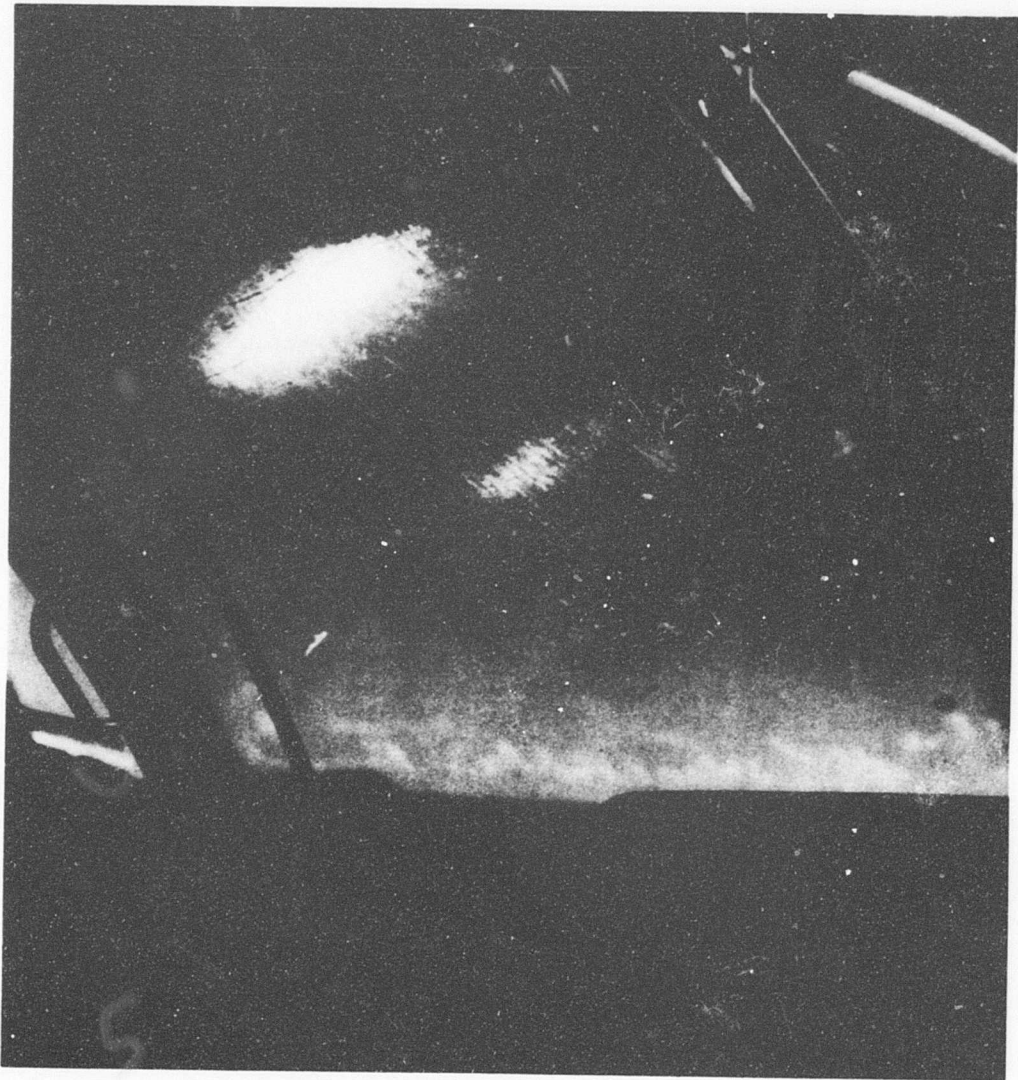
Figure 18. Crazing on Plastic Windshield, OH-6.

Crazing of acrylic and polycarbonate can be described as minute cracks in the surface of the material. Whereas scratches are directional and tend to be longitudinal, crazing is more of a network and branches of small fissures. While scratching is caused by mechanical action, crazing for the most part is caused by chemicals. Table 61 lists chemicals and their effect on various plastics.

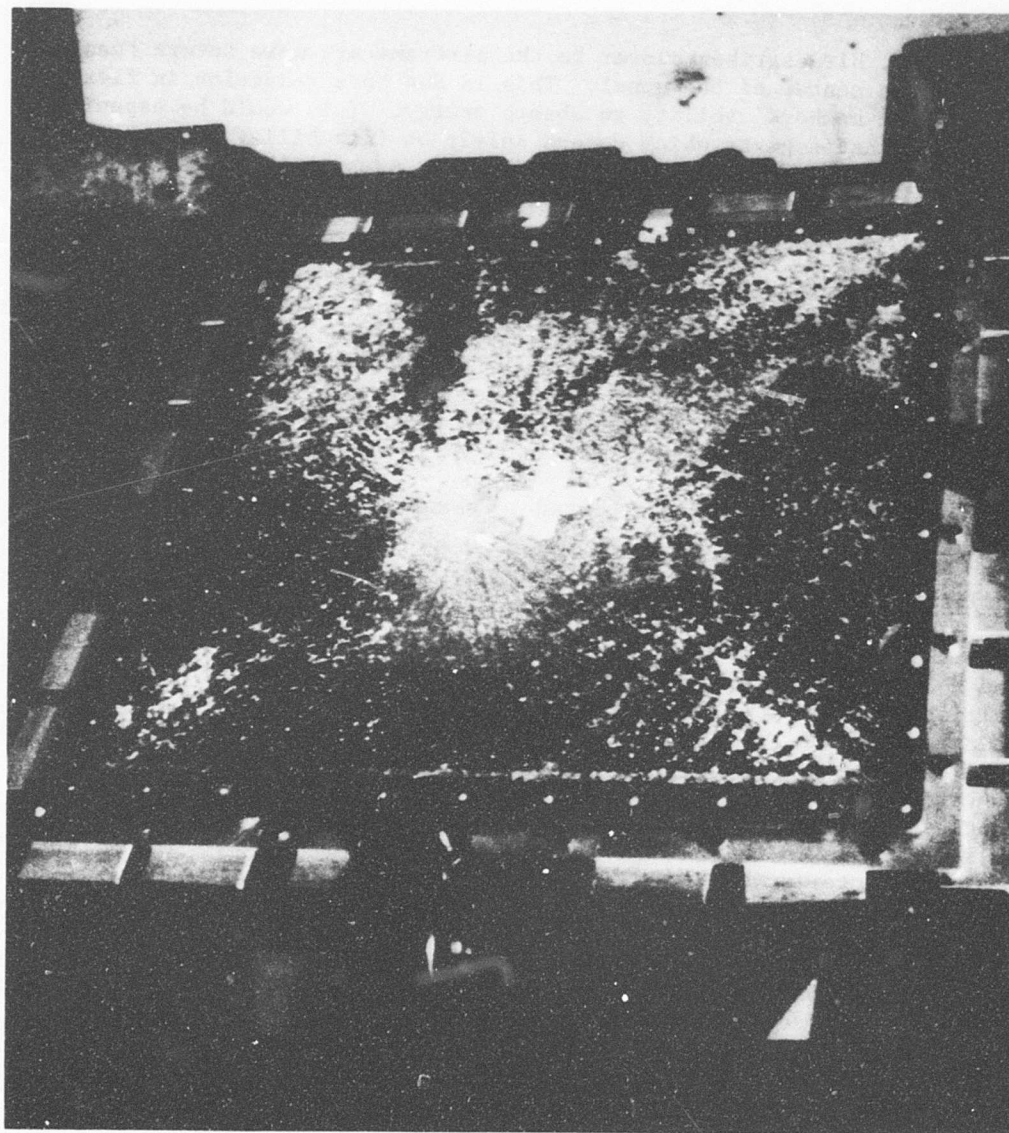
Figure 19 shows the result of a 1-pound bird impacted at the center of the panel at a speed of 101 kt (116 mph). Both plies of glass shattered, but there was no bird penetration past the windshield. Residual vision would be very poor through the windshield after such a strike, and landing would have to be accomplished from the side or copilot windshield. Subsequent strikes were also made at 150 kt (173 mph) with a 1-pound bird and 89 kt (102 mph) with a 4-pound bird. No penetration was obtained with the former, but the 4-pound bird did penetrate.

Figure 19. Bird Shot Damage of Center Windshield,
CH-53.

The mode of failure under bird-impact loading is such that the basic tensile strength of the glass is overcome. The loading is so rapid that the interlayer yields very little and the two pieces of glass instantaneously act as a solid. Once the glass fractures, energy absorption is taken over by the interlayer. If this member is sufficiently thick, it will "bag" the bird and prohibit penetration. If not, the interlayer tears and the bird penetrates into the cockpit.

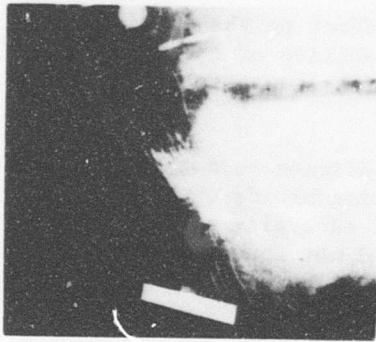
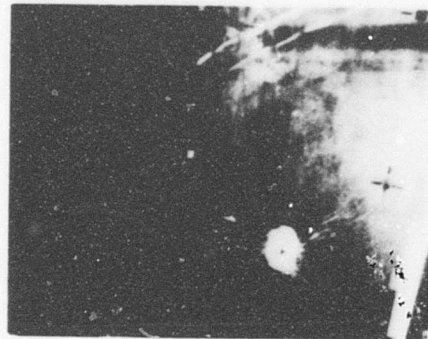
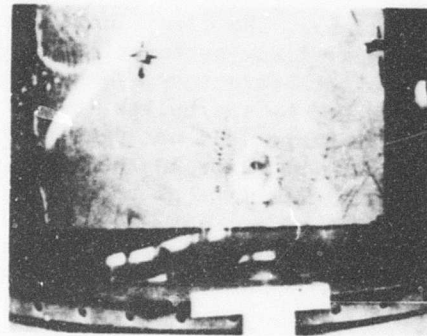
Figure 20. Ballistic Tests of CH-47 Windshields
Soviet 7.62 X 39 mm Ball Ammo.

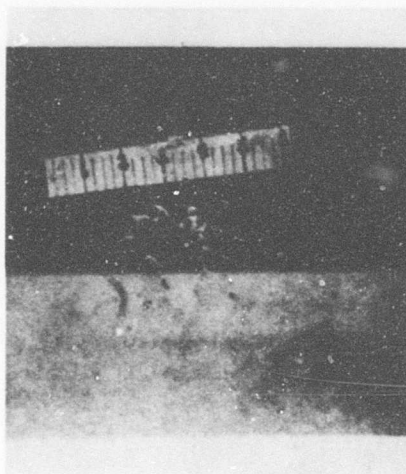
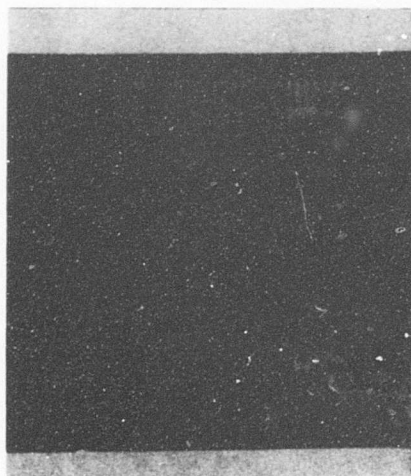
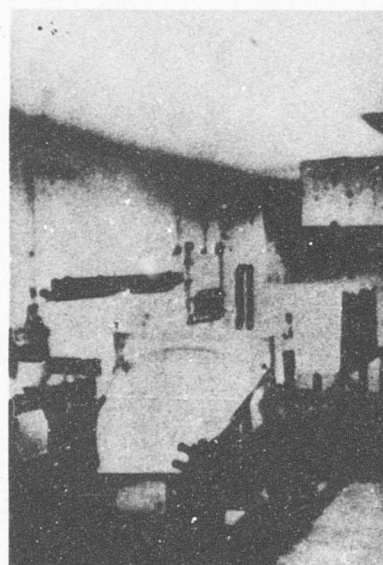
Typical Plexiglas Results

Target Arrangement

Figure 21. Ballistic Tests
Arrangement and
Plexiglas Results.

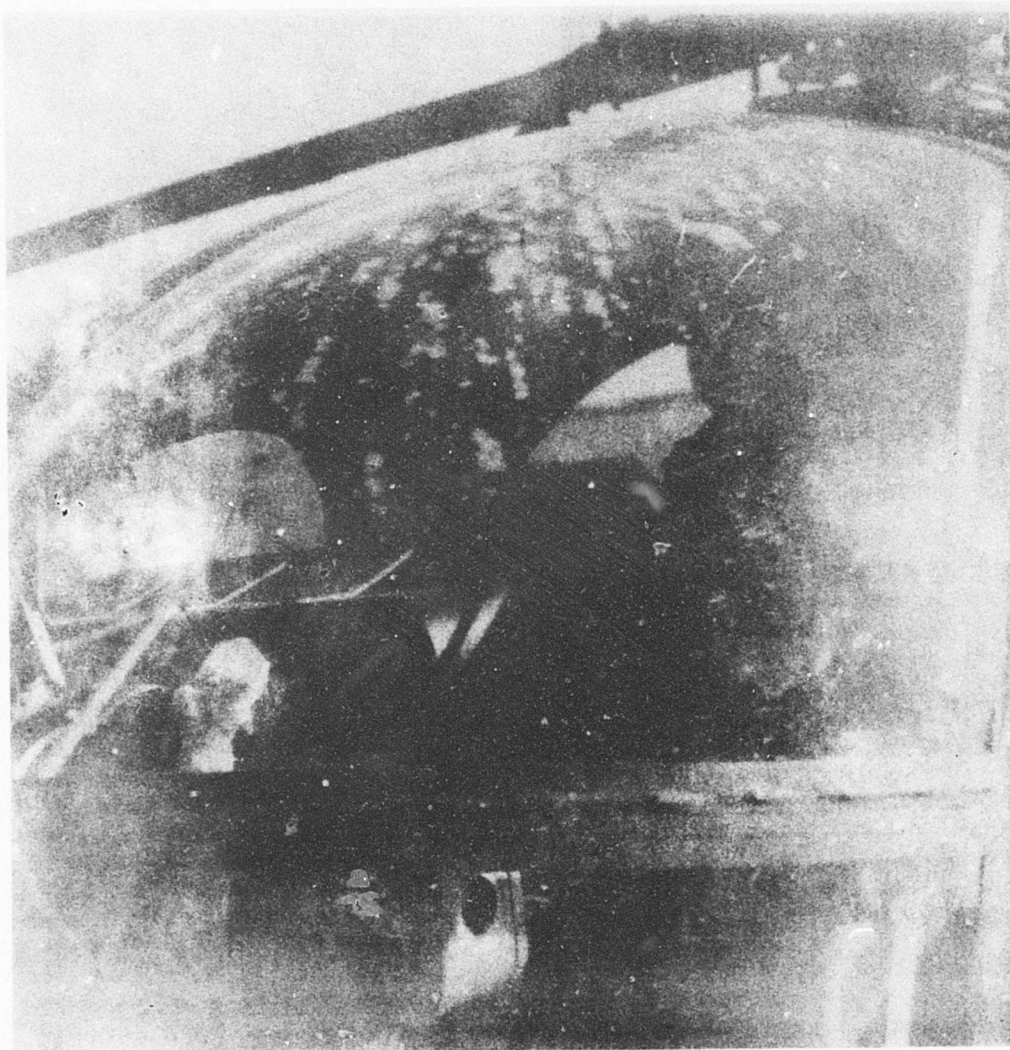
Figure 22. Outside View of OH-6 Windshield
Showing Taping to Airframe.

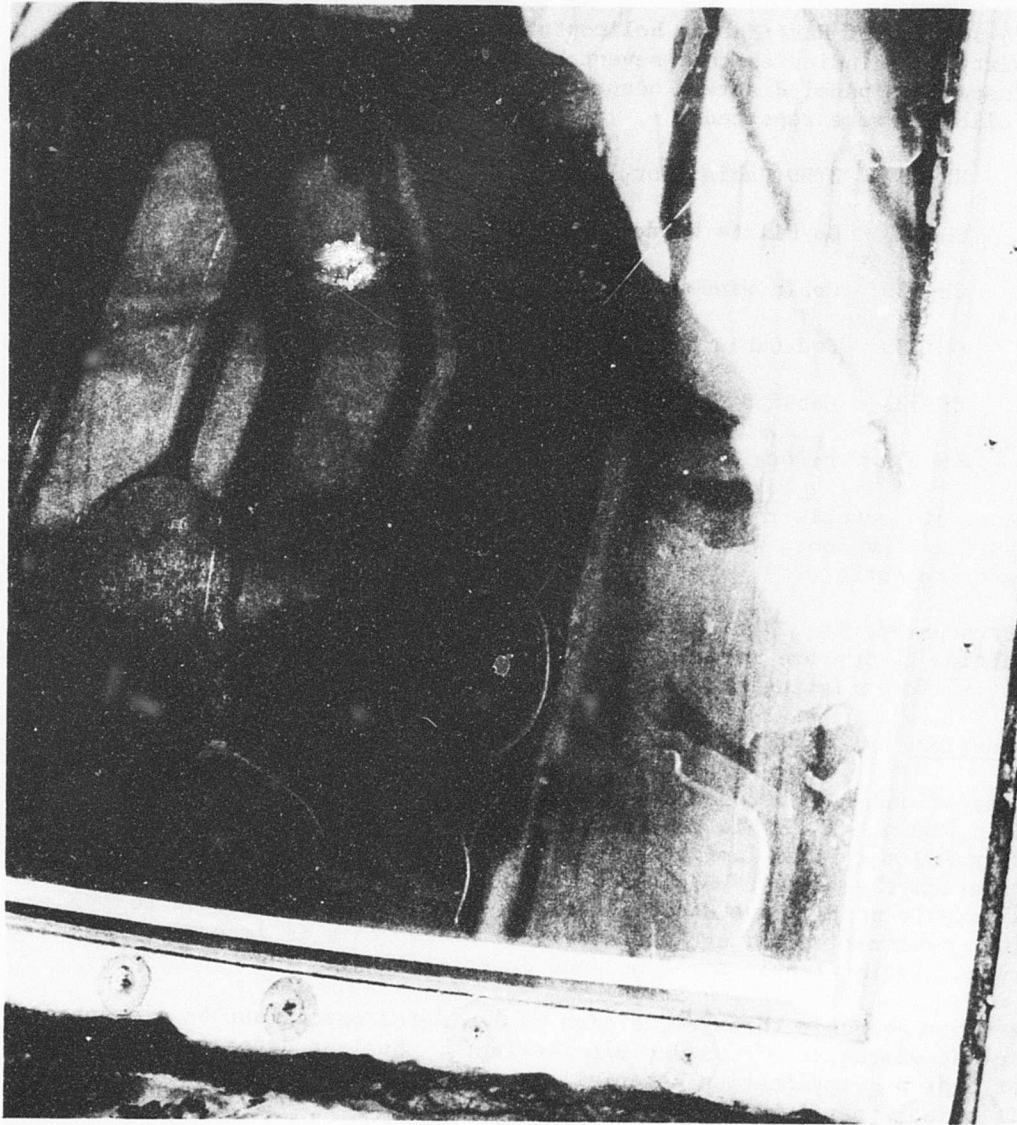
Figure 23. Severe Delamination of Plastic Windshield, CH-47.

Differences in the coefficient of thermal expansion of materials in a laminate affect delamination. The coefficient of thermal expansion of the normal interlayer material (PVB) is approximately ten times that of glass. As a laminate of glass/PVB/glass experiences gross temperature changes, extremely high shear forces parallel to the surface exist at the glass-PVB interface that contribute to adhesion failure. This is also true for glass/PVB/acrylic composites. However, additional bending stresses exist because of the unbalanced glass-acrylic configuration.

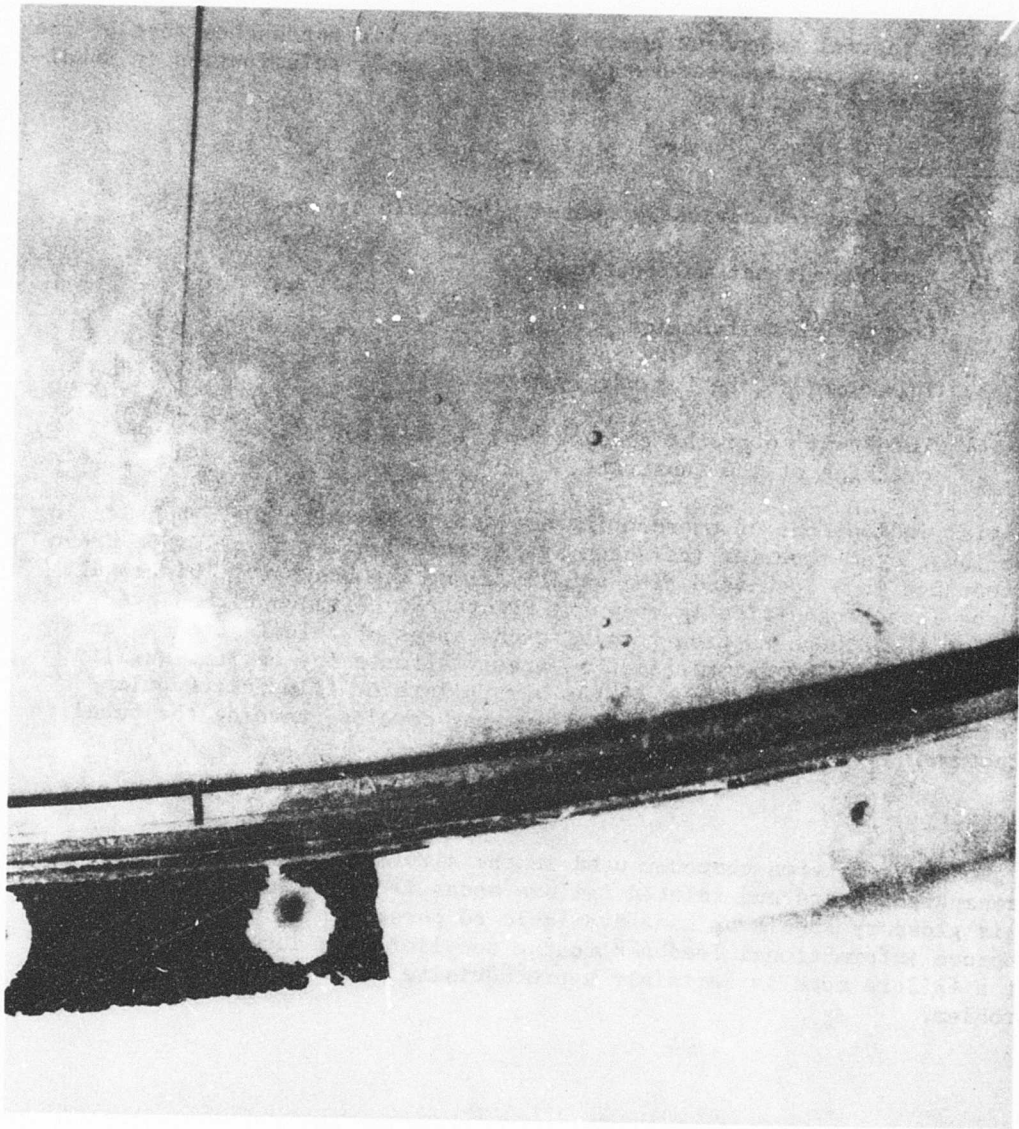
Figure 24. CH-53 Windshield Showing Bubbles
Caused by Overheating.

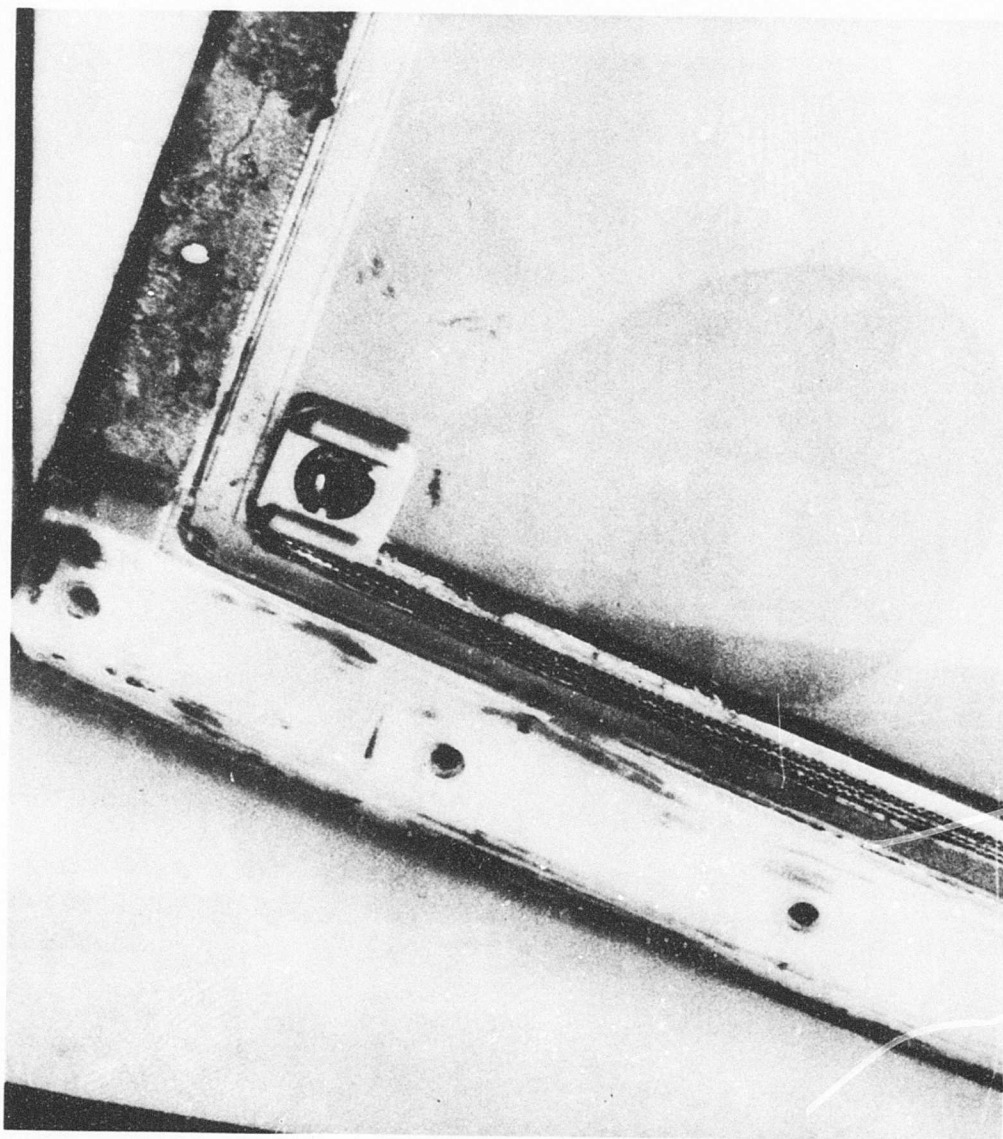
Figure 25. Bus Bar Failure Leading to Overheating and Delamination of Plastic Windshield, CH-53.

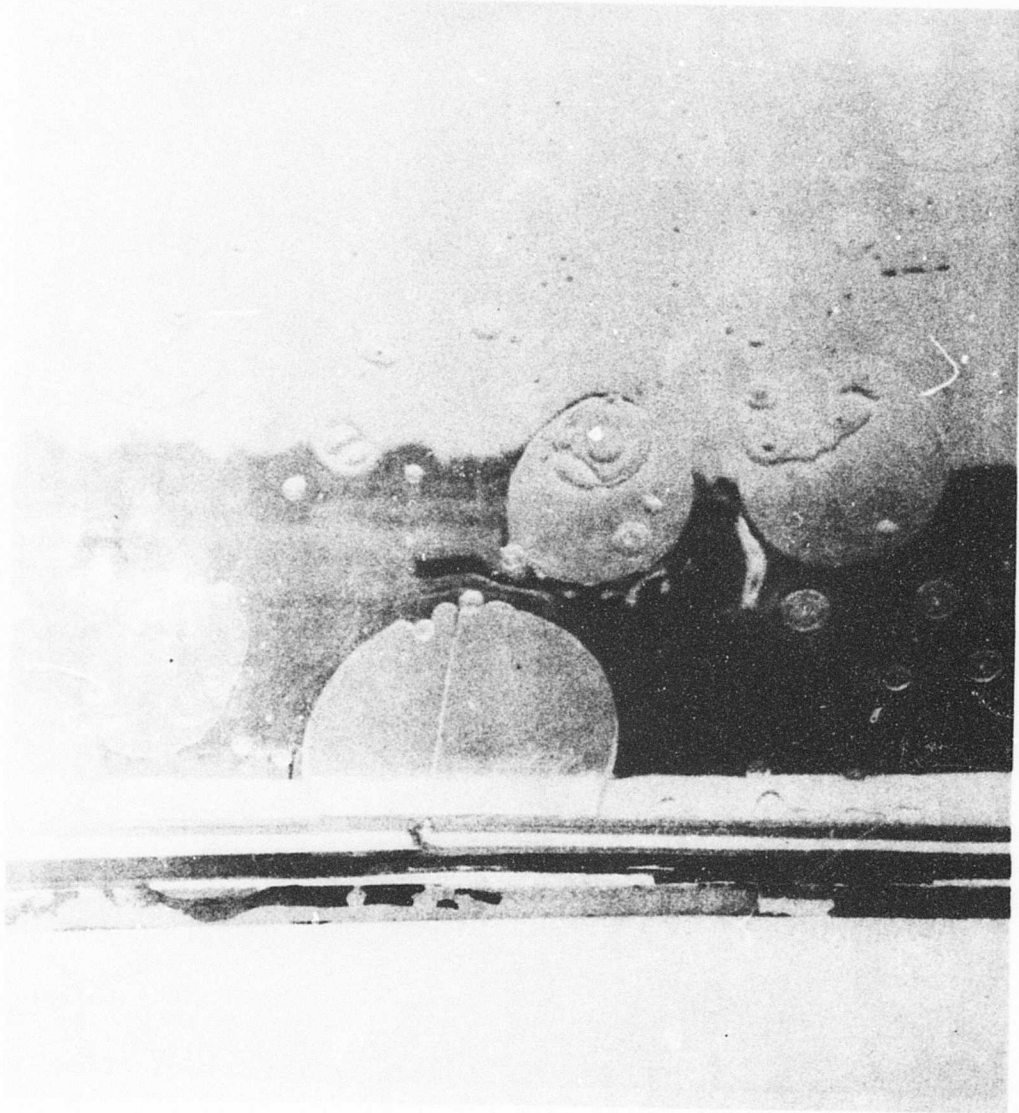
Figure 26. Bubbling Caused by Overheating
Progressing to Severe Delamination
on Plastic Windshield, CH-46.

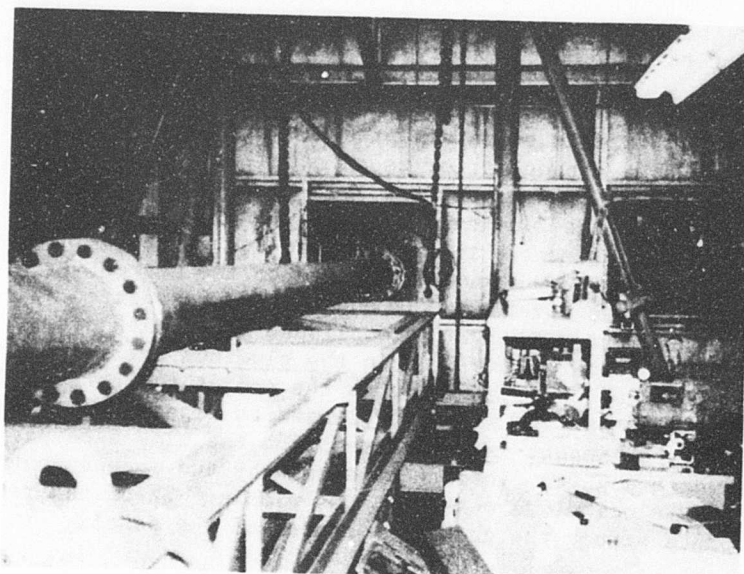
Figure 27. Bird Impact Test Facility Showing
Gun Barrel Pointing at Panel.

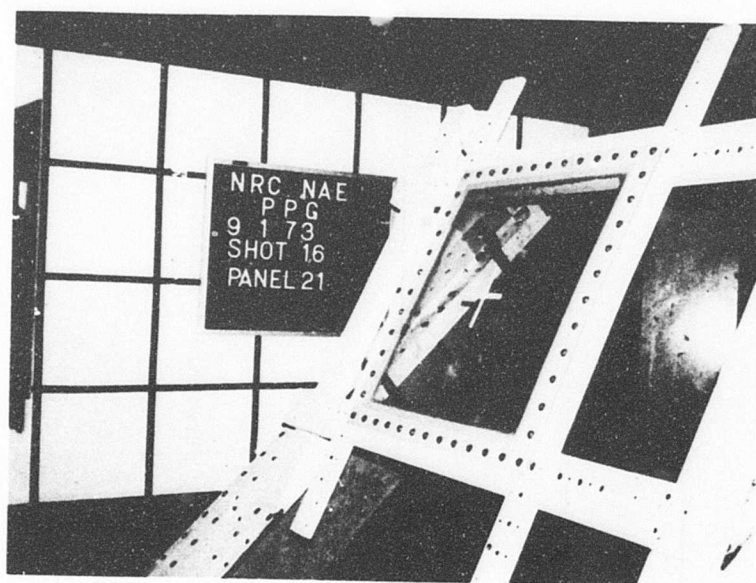
Figure 28. Typical Impact Test Setup of
26-In. X 26-In. Panel at 65°
Installation Angle, $70 \pm 5^{\circ}\text{F}$.

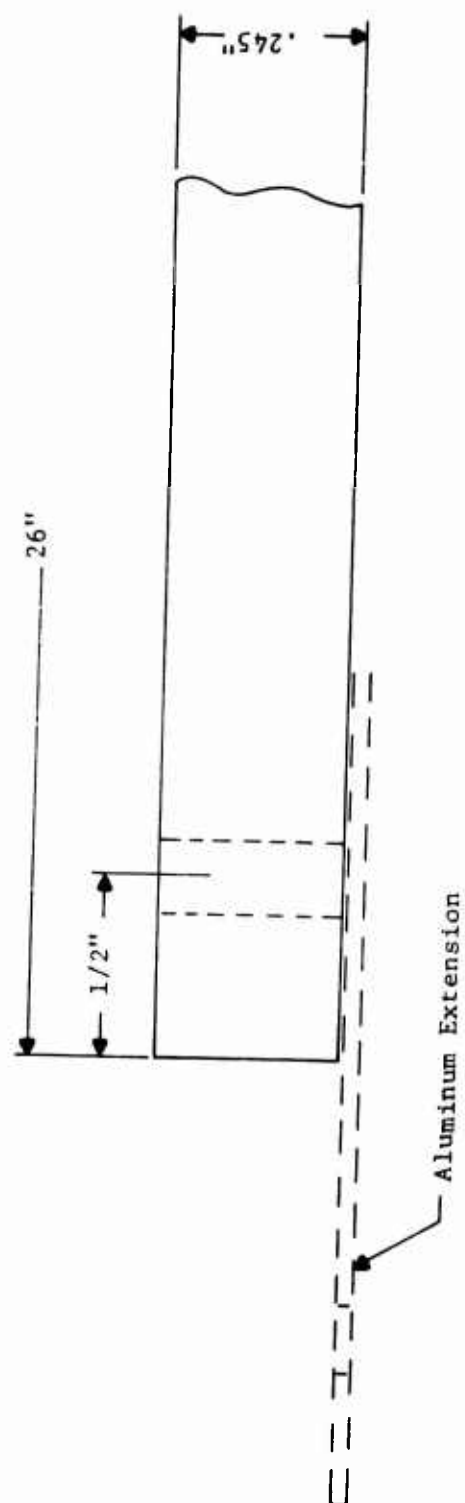
Figure 29. Design I: Monolithic 1/4-In. Stretched Acrylic.

Figure 30 shows the results of 4-lb bird impacts of 1/4-in. stretched acrylic design as shown by Figure 29 at velocities of 100 and 150 mph. In

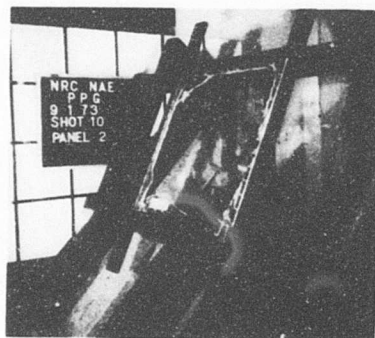
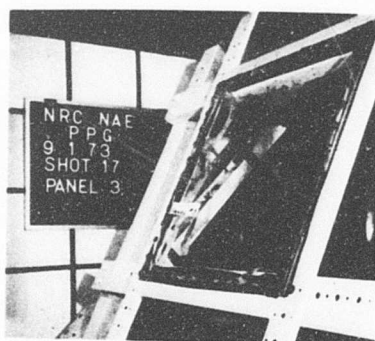
Forward

Panel No. 2 at 101 MPH

Close Up Forward View

Rear View

Panel No. 3 With Rubber Gasket at 100 MPH

After panel No. 1 showed a complete failure with no resistance at 150 mph, panel Nos. 2, 3 and 4 were shot at 100 mph. As shown in Figure 30, panel No. 2 offered no resistance to the 4-lb bird. The fracture was entirely brittle with no material deformation. The apparent origin was located at a drilled bolt hole. Therefore, subsequent tests at the same velocity utilized modifications to enhance the performance. Addition of a .030-in. rubber gasket between the contacting surfaces of the acrylic and frame produced no advantage, as shown by the photographs of panel No. 3.

The final modification to improve the material performance consisted of a flexible aluminum .060-in. extension ring that was bolted to the expanded steel frame. Although the acrylic sample attached to this aluminum ring achieved a more flexible support, the 4-lb bird easily penetrated the sample. Some larger pieces remained attached to the ring, as shown by the photographs of panel No. 4, indicating that the ring did absorb some energy. However, deformation of the ring was minor and the failure continued to start at a bolt hole.

In general, these tests indicated that stretched acrylic is a rather brittle material when subjected to impact especially if some structural damage is present. Undoubtedly, the use of drilled holes through this material without reinforcement seriously weakened stretched acrylic's impact resistance to the bird strikes. Although this inherent problem could be eliminated by attachments, as now used on aircraft as shown in Appendix III, the severe vulnerability of this material to damage would always be suspect.
